Flamingo mortality due to collision with high tension electric wires in Gujarat, India

Citation: Tere, A. & B.M. Parasharya (2011). Flamingo mortality due to collision with high tension electric wires in Gujarat, India. *Journal of Threatened Taxa* 3(11): 2192–2201.

Abstract: This study documents the mortality of flamingos due to collision with electric wires in the state of Gujarat, India. The wetlands of Gujarat were surveyed from 2002 to 2005 as a part of ecological studies on flamingos. Incidences of collision of flamingos with overhead electric wires were recorded at breeding and feeding sites. The numbers of victim birds were counted and high risk sites were identified based on reported incidences of collision and the period of inundation of the sites below electric lines. Of the 76 deaths recorded, Lesser Flamingos *Phoeniconaias minor* (46%) and Greater Flamingos *Phoenicopterus roseus* (54%) accounted almost equally. The effects of collision on the population of flamingos and the management options to minimize collision of flamingos and other water birds with electric lines in sensitive habitats are discussed.

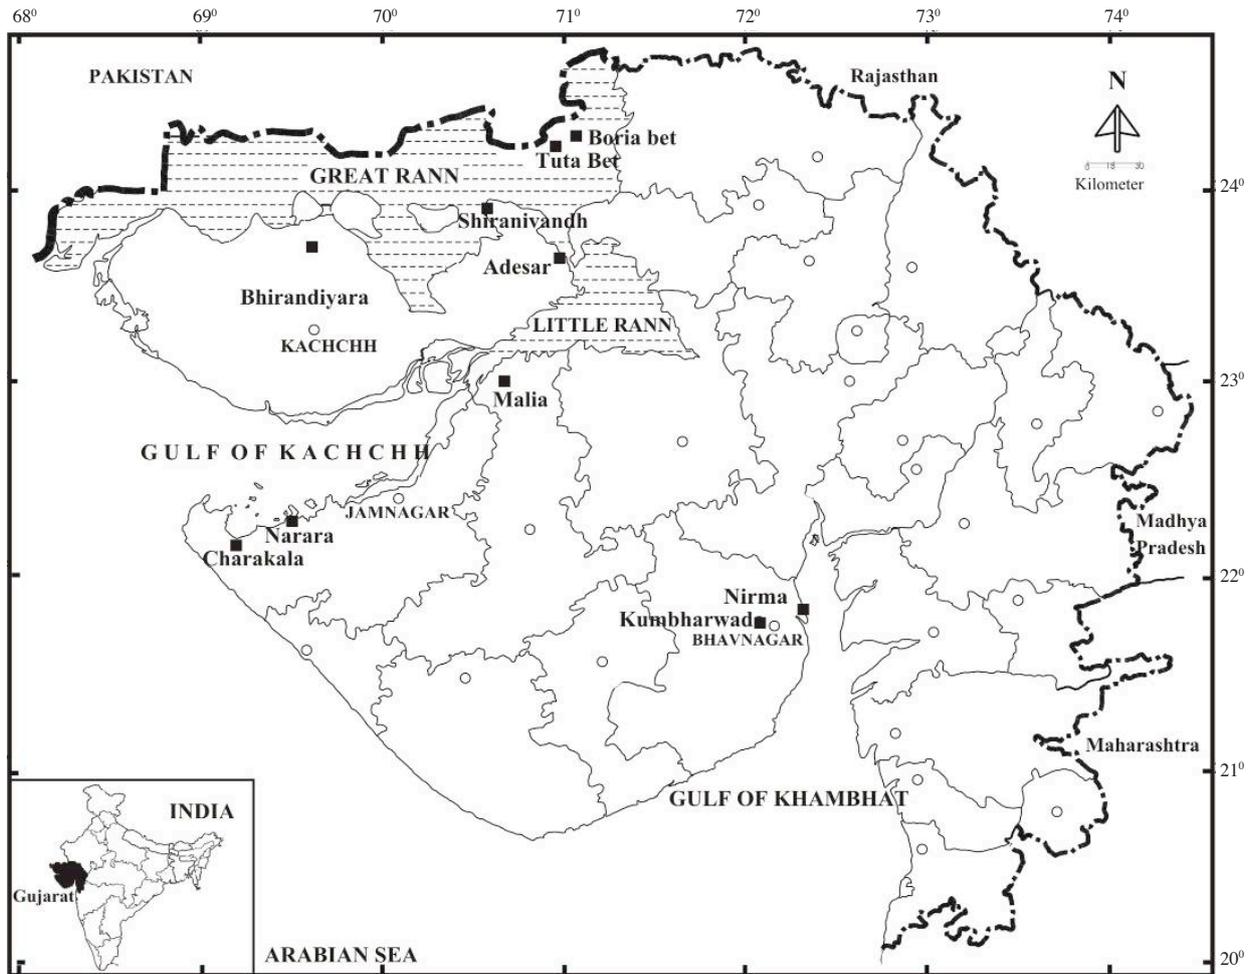
Figure 1. Sites of regular flamingos collisions in Gujarat State, India, marked as solid square (■).

(summer) season. For additional details of the study sites refer to Jadhav & Parasharya (2004). The sites of collision are marked with a solid square (■) on Figure 1 of the study area.

Two incidences of collision were recorded at Vekariodhandh near Bhirandiyara, 50km north of Bhuj, on the Bhuj-Khavda road in Kachchh (Fig. 1, Table 1). On 14 January 2004, seven Greater Flamingos were found dead due to collision with the electric wire at this site (S.N. Varu pers. comm.). On 14 February 2004, two more dead Greater Flamingos were found at the same site in the morning hours. The bodies were slightly warm and not disturbed by predators. Such collisions are frequent at this particular site (Amin

In the first weeks of July 2004 and 2005, one Lesser Flamingo was found dead after collision with electric transmission wires in a salt pan area at Malia (Fig. 1, Table 1). Huge electric transmission lines run parallel to the salt pans and cross the Hadakia Creek at Surajbari

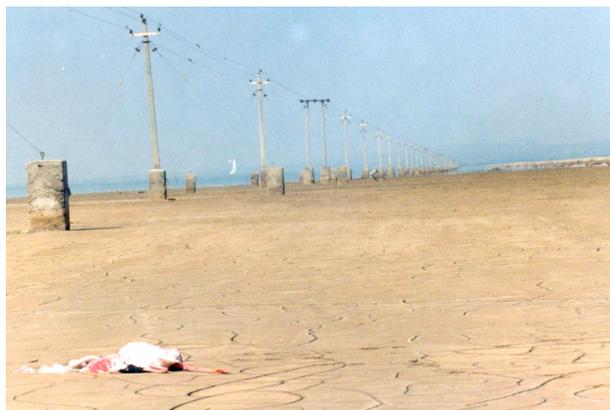
Image 1. Collision of Lesser Flamingo with distribution line at Shiranivandh

paper; Image 1). The distribution lines were supported by a small single pole; (ii) High tension power lines or Transmission lines (Image 2) consisted of three sets of parallel wires and a top earth wire of 207mm²

At Shiranivandh, the power line (distribution line at low height) runs parallel to the 10km long bridge constructed across the inundated Rann connecting the former with Khadir Island (Beyt). During October 2003, the area on either side of this road was inundated. A total of 600,000 Lesser Flamingos and 20,000 Greater Flamingos were counted in this inundated area. On 23 October 2003, when we were observing the flamingos we saw two domestic dogs chasing them in shallow water at the other end. All the flamingos close to the dogs flew away but one which struggled to stand and take off. We rescued it and realized that its right wing was severely damaged and had a wound on the upper surface. A total of eight Lesser Flamingos were recorded dead due to collision with the overhead power lines along the road during a five day period (Table 1). Freshly collided flamingos were recorded during the morning hours, suggesting that the flamingos collided with the wire during the low light hours (Image 1).

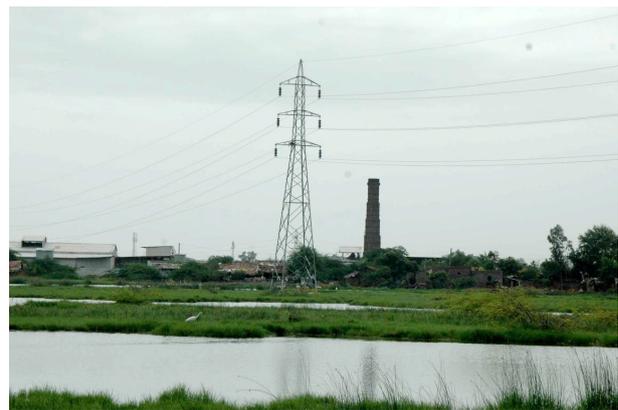
Image 2. Transmission line across wetland at Kumbharwada, Bhavnagar. Note thin earthing wire on top

steel-reinforced aluminium, with the lowest set 6.1m from the ground and the terminating ground wire 10–12 m from the ground, and carrying 11000–13500 V electricity (Sundar & Choudhury 2005; referred to as

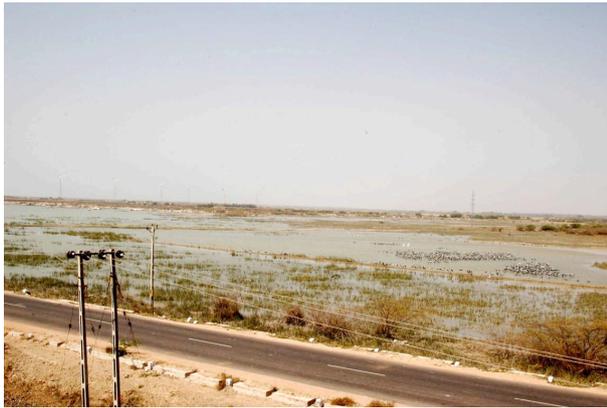
Image 3. Distribution line, telephone line and transmission line across a wetland.

Telephone wires, usually a pair, were fixed at a height of 6.0 m above the ground. Such wiring was responsible for collision at only one place. At some sites, both electric lines and telephone lines crossed a wetland (Image 3).

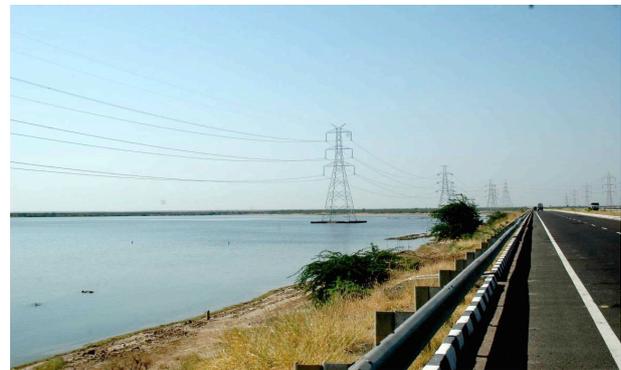
Image 4. Two parallel transmission line between Little Rann and Great Rann near Adesar, Kachchh.

site was about 19km west of Santalpur and had huge electric poles with three pairs of overhead transmission wires. The birds flying between Little Rann and Great Rann have to cross this corridor and hence the risk of collision is very high in this 5-km stretch. Moreover, near Adesar, there is a water body spread over a 2.5km² area, parallel to the road and just below two parallel transmission lines (Image 4). Both species of flamingos feeding in this wetland are at very high risk of collision as they are often disturbed by vehicular traffic on the road.

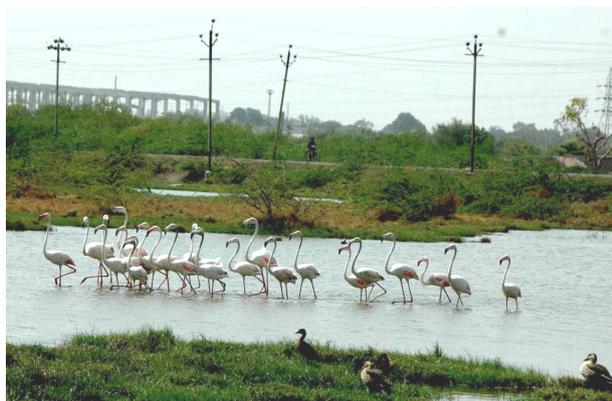
Image 5. Risk of collision with distribution line at Bhavnagar.
